# Long-term dam safety monitoring of Punt dal Gall arch dam in Switzerland

M. WIELAND<sup>a,\*</sup>, G.F. KIRCHEN<sup>b</sup>

**ABSTRACT** The 130 m high Punt dal Gall dam is located at the Swiss-Italian border in the South-eastern part of Switzerland and was completed in 1969. The dam is founded on highly folded and partially crushed dolomite and limestone formations. A grout curtain with an area of 120,000 m<sup>2</sup> was provided for controlling seepage. For the monitoring of the dam deformations five inverted pendulums were installed in the dam and three in the rock foundation of the right abutment outside of the dam. For a seasonal water level fluctuation in the reservoir of about 60 m the maximum amplitude of the radial displacement is 25 mm, which includes both the effects of the water load and temperature effects. Furthermore a comprehensive geodetic network was established, 57 joint meters were installed and cracks in the crest gallery are monitored by crack meters. There are also thermometers, piezometers and rocmeters. Springs at the left and right banks of the dam are monitored and chemical analyses of the seepage water and springs are performed regularly. The dam

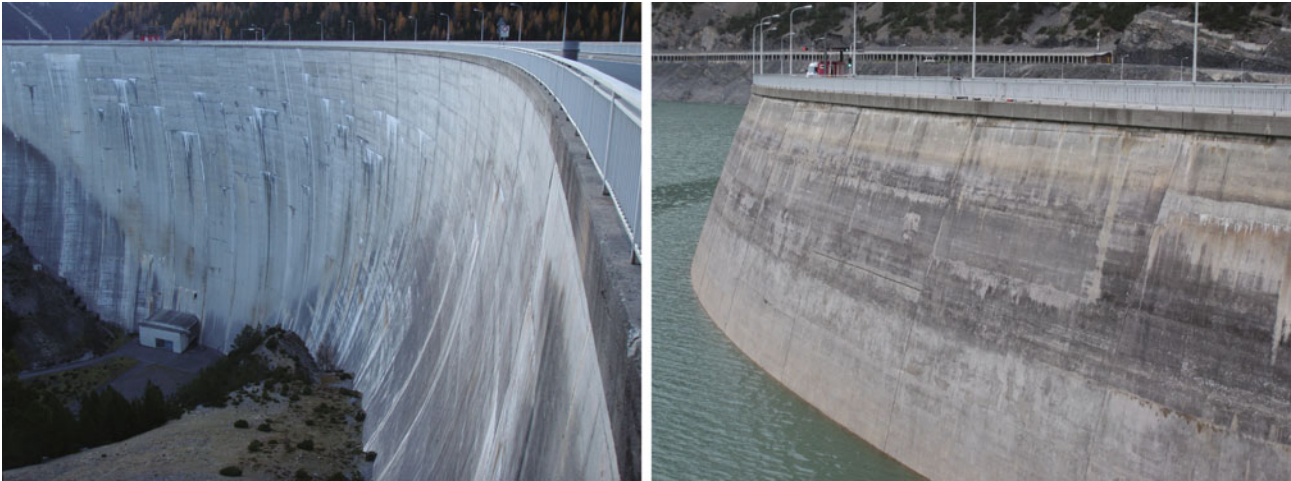
Fig. 3 Views of downstream (left) and upstream (right) faces of the dam

At the upstream face some local signs of frost damage

can be seen. At the downstream face some efflorescences are visible, mainly along concrete lifts in the upper part of the dam, which are subjected to seasonal wetting and drying. These features are monitored photographically. Of importance is if new wet spots have developed or leakage has increased. The situation has been stable. A problem with wetting and drying in combination with freezing temperatures is that aging of the concrete at the dam surface is faster than in other parts not exposed to such processes and weather.

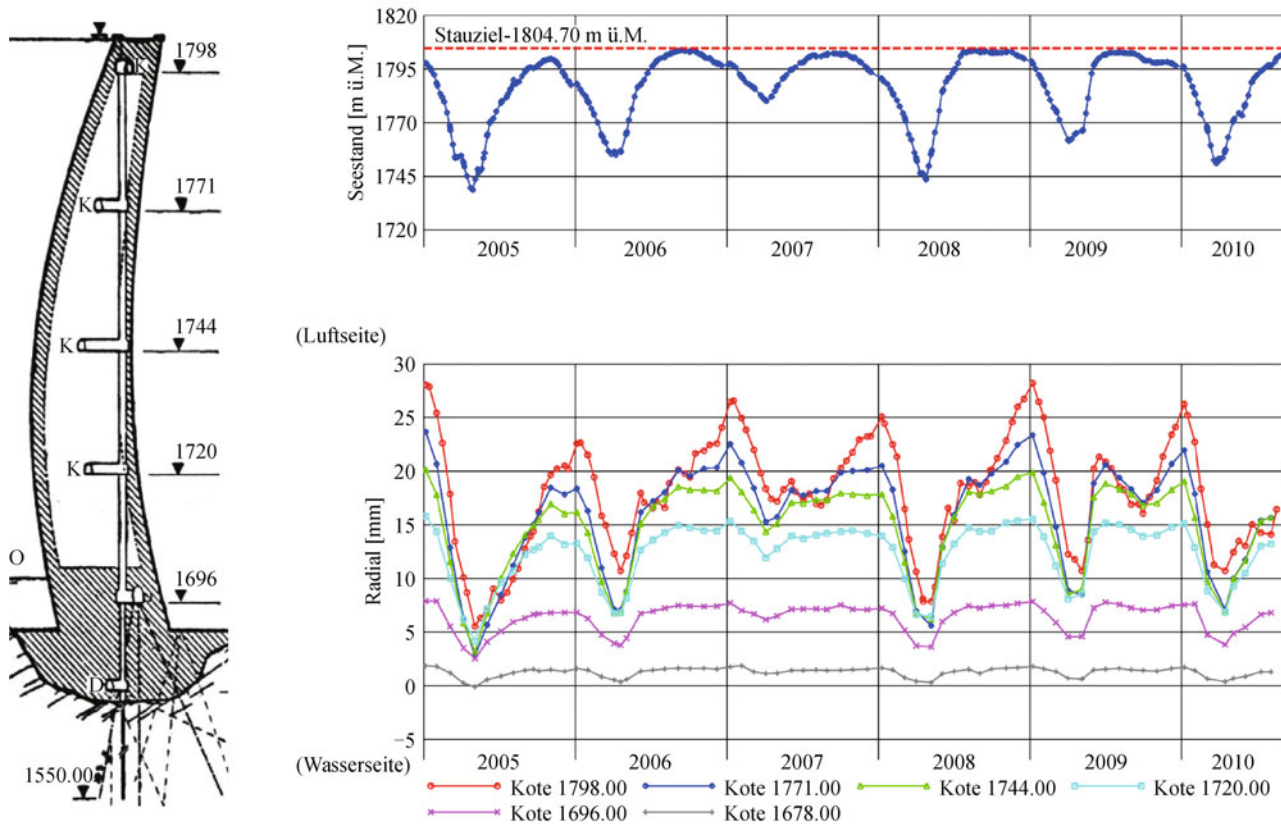
The main types of monitoring equipment installed in the Punt dal Gall arch dam are as follows: inverted pendulums, joint meters, crack meters, rocmeters, manometers (uplift pressure), and temperature gauges in concrete. The deformations of the dam are measured by inverted pendulums as shown in Fig. 4. Due to the strong seasonally varying temperature effects the maximum radial displacement of the dam is in winter when the water level in the reservoir is already decreasing. The maximum annual

amplitude of the radial displacement is about 25 mm; the tangential displacements are small.

**Fig. 4** Time histories of radial displacements at six elevations of inverted pendulum in block 17. The seasonal water level variation is shown in top figure

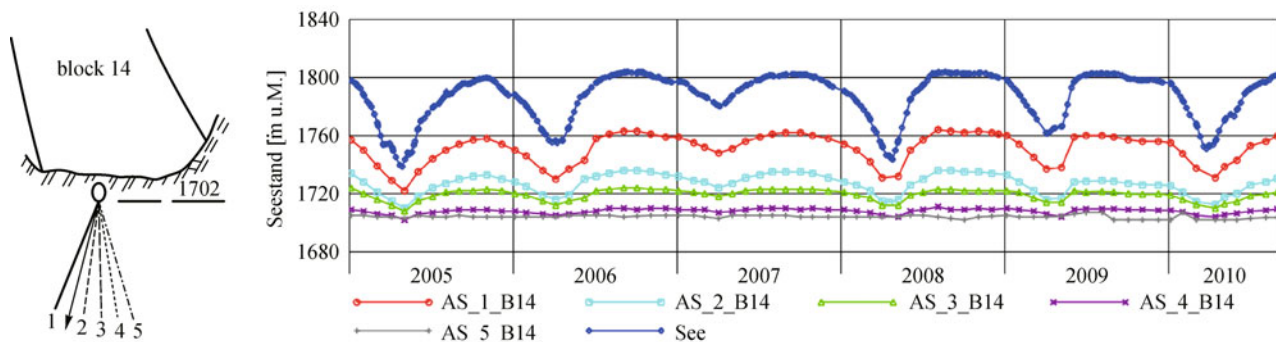
In Figs. 5 and 6 the variation of the uplift pressure is depicted. It can be seen that the pressure in boreholes AS1 to AS3 varies with the water level in the reservoir. Also from the long-term records 1990–2010 no qualitative changes in the pressure regime can be found. As the grout curtain has not a uniform thickness, the pressure in the borehole AS1, which is located upstream of the theoretical location of the grout curtain, is smaller than the hydrostatic pressure from the reservoir. This indicates that the grout curtain also extends into the zone of borehole AS1.

**Fig. 5** Uplift pressure measurements at five locations in block 14 (grout curtain is located between drillholes 1 and 2 (left))

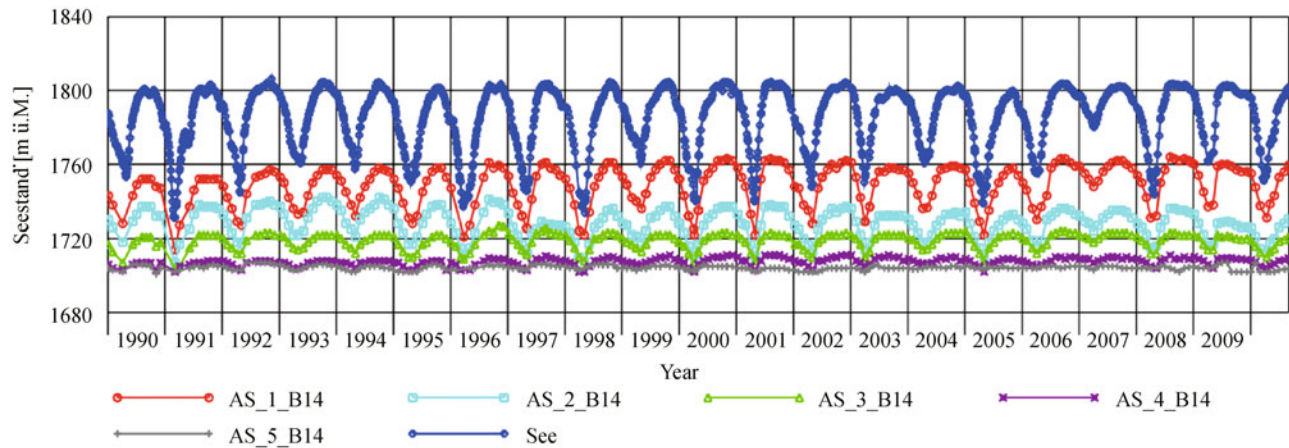
**Fig. 6** Long-term uplift measurements in block 14 (Note: The top curve represents the seasonal variation of the reservoir water level)

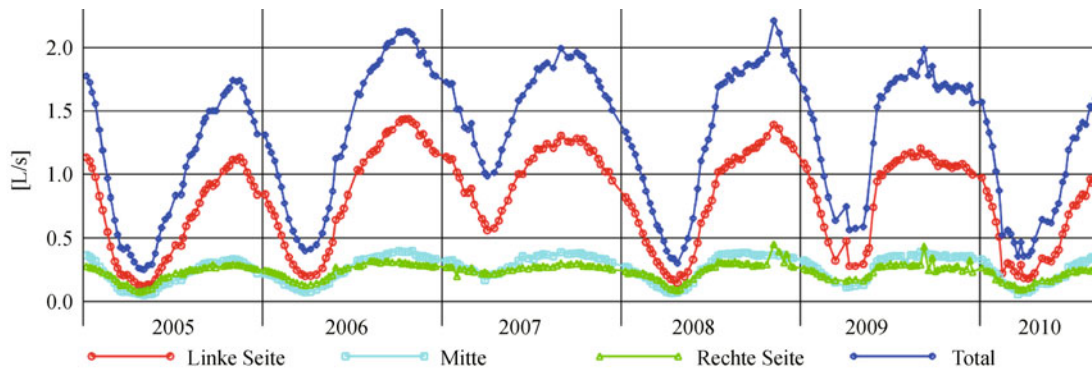
Figure 7 shows the seepage water collected in three different zones of the dam. The total seepage is less than 2.2 l/s. Most of the seepage water comes from the left abutment zone. As expected, the total seepage is directly correlated with the water level in the reservoir.

**Fig. 7** Time history of the seepage water collected from three zones of the dam, i.e., Linke Seite (left), Mitte (middle) and Rechte Seite (right)

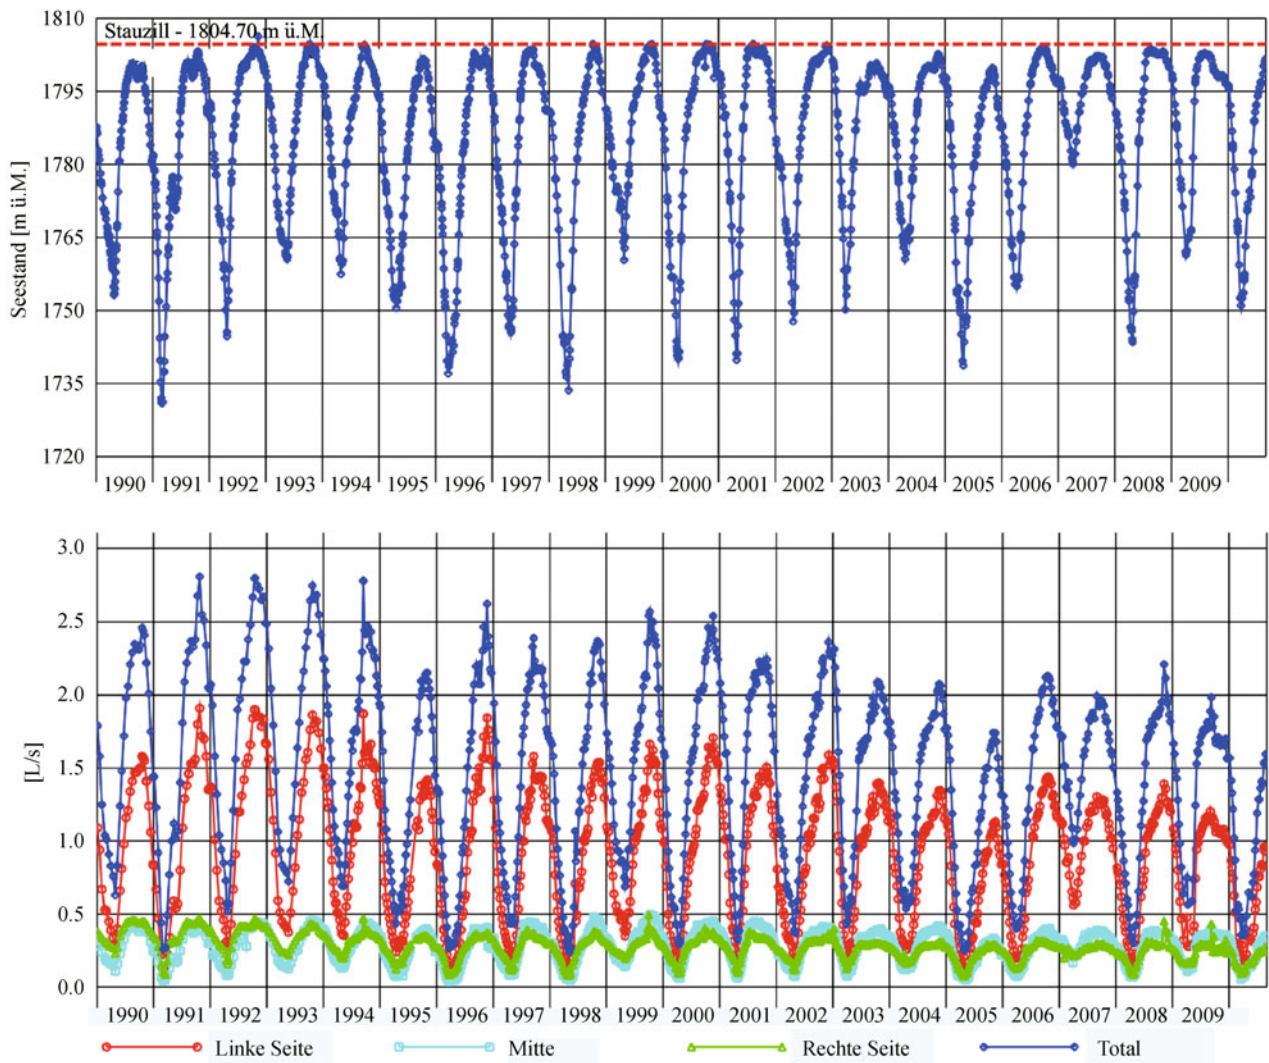
From Fig. 8 it can be noted that the maximum seepage water has reduced from ca. 2.8 l/s in 1990 to 1.5 l/s in 2010, which may be due to clogging of parts of the boreholes.

**Fig. 8** Long-term record of seepage water collected from three zones of the dam, i.e., Linke Seite (left), Mitte (middle) and Rechte Seite (right)

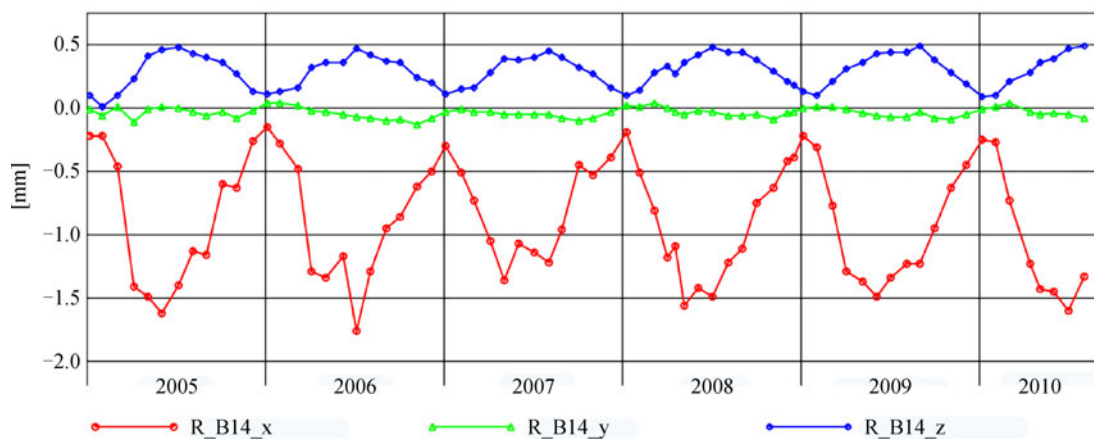
Finally some cracks have developed mainly in the uppermost control gallery of the dam. Some of the larger cracks are equipped with crack meters. As can be seen from Fig. 9 the crack width is also varying with time. The cracks are opening in winter and are closing in summer when the concrete temperature near the dam crest is

maximum. In Fig. 9 the reference axis is that at the time when the crackmeter was installed and the crack was open. The crack opens by about 1.5 mm within one year.

3) Cracks have appeared in the crest gallery and the spillway structure; however, they are stable and are not related to a critical failure mode.

**Fig. 9** Crack opening displacement of crack in crest gallery in block 14 as function of time (x: opening displacement; y and z: tangential movements of crack surfaces)

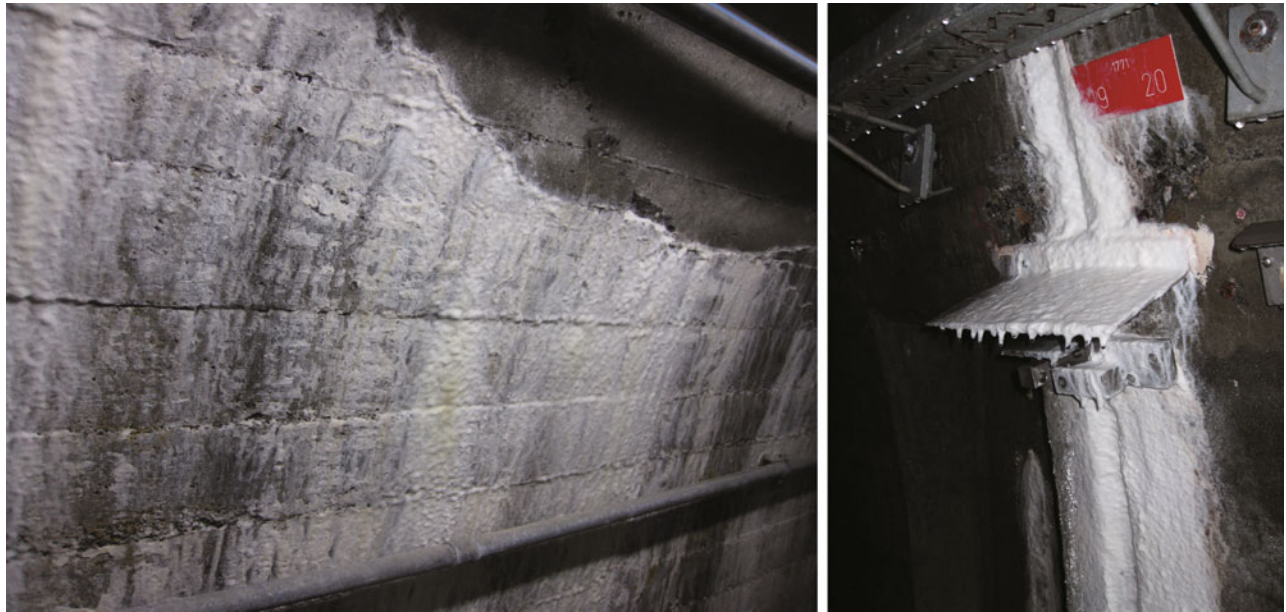
Moreover, in some of the wet or temporarily wet vertical block joints, lift joints and old cracks of the control galleries efflorescences are visible as shown in Fig. 10. They may affect the monitoring instruments. However, this is a maintenance issue rather than a dam safety issue. Nevertheless, this is a feature, which can be observed in many concrete dams. Optically these efflorescences are disturbing.

**Fig. 10** Efflorescences in control galleries at crack (left) and at joint meter location (right)

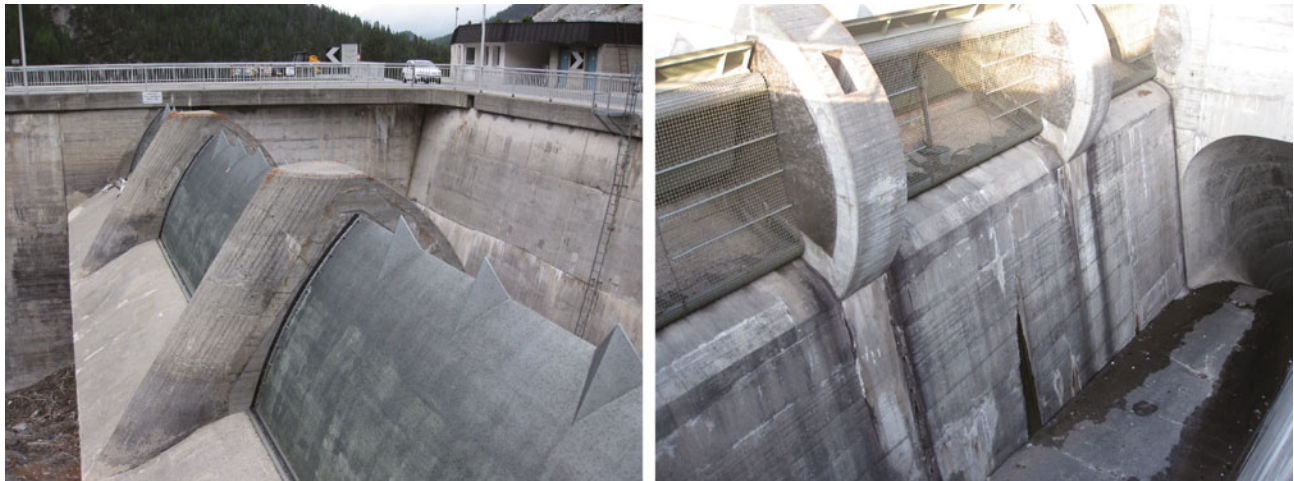
The surface spillway connected to a tunnel has a capacity of 270 m<sup>3</sup>/s. It is located on the right abutment (Fig. 11) and the downstream face of the gate is protected by a steel net. In addition, there is a bottom outlet with a capacity of 200 m<sup>3</sup>/s. Operation of the spillway and the bottom outlet are also checked annually. In recent years, due to ecological reasons, an artificial flood was created in summer with a peak discharge of 41 m<sup>3</sup>/s and 8 h duration. The environmental flow is 1.44 m<sup>3</sup>/s. A special hydro-

**Fig. 11** Upstream (left) and downstream (right) view of spillway of Punt dal Gall dam
